Copper and Silver Water Treatment

Corrosion Report

**Are metal ions of copper and/or silver
corrosive to pipework?**

A Study Report

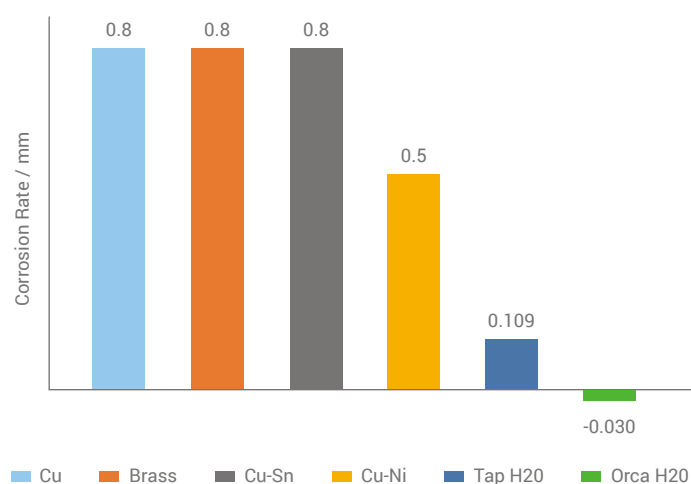
As can be seen in Figure 2, both type of water gave a corrosion rate of 10 years' service life much lower than the global standard allowance. Moreover, tap water containing copper and silver ions gave slightly negative corrosion rate.

Figure 2: Overall corrosion rate comparison

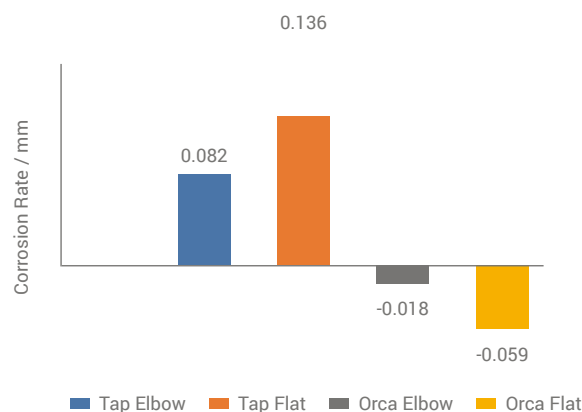
The tested copper coupons indicated that the water from the Orca CSI system gave negative corrosion rate (Fig. 3) when compared with ordinary tap water, which showed a corrosion rate of approximately 10% of the regular allowance.

Figure 3: Corrosion rate variation at two locations (elbow or flat pipe surface).
